No. 1246

WIND-TUNNEL INVESTIGATION OF ICING OF AN ENGINE
COOLING-FAN INSTALLATION

By James P. Lewis

TECHNICAL NOTE NO. 1246

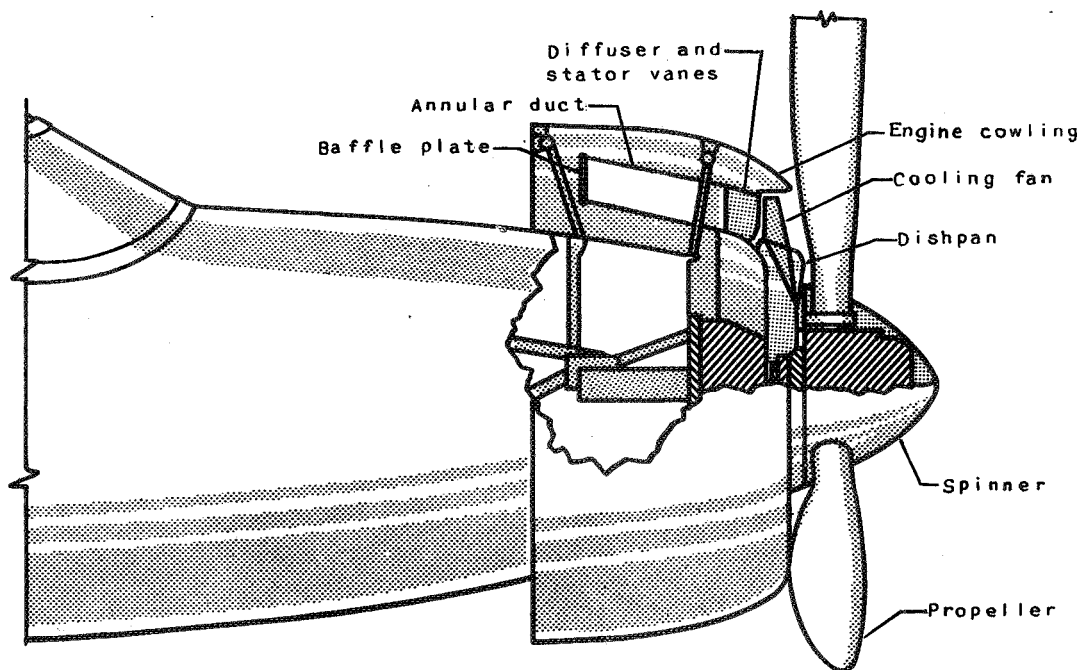
Figure 1. - Engine cooling-fan installation.

The investigation was conducted in the diffuser section of the icing research tunnel. The cooling-fan assembly was mounted on the modified nose section of an airplane fuselage installed in the tunnel. The installation consisted of a typical propeller-speed engine cooling fan, a stator-vane and diffuser assembly, a baffle plate located in a constant-area annular duct downstream of the fan to simulate the pressure drop across the engine, a standard radial-engine cowling, a three-blade propeller and spinner, and necessary instrumentation. (See fig. 1.)

Cooling fan. - The cooling-fan assembly was designed to be mounted at the front face of a radial engine and enclosed by the engine cowling with the fan rotor attached to the rear of the propeller hub and the stator-vane assembly attached to the reduction-gear housing. The front fairing of the fan disk was of the "dish-pan" type with a large forward bulge at the outer diameter of the dishpan. The fan had 72 cambered sheet-metal blades with a tip diameter of 43 inches and a tip clearance of three-sixteenths inch. As part of the cooling-fan assembly, 49 cambered sheet-metal stator vanes were located behind the fan to remove the rotational component of the flow. A clearance of seven-eighths inch existed between the fan blades and stator vanes. (See fig. 1.)

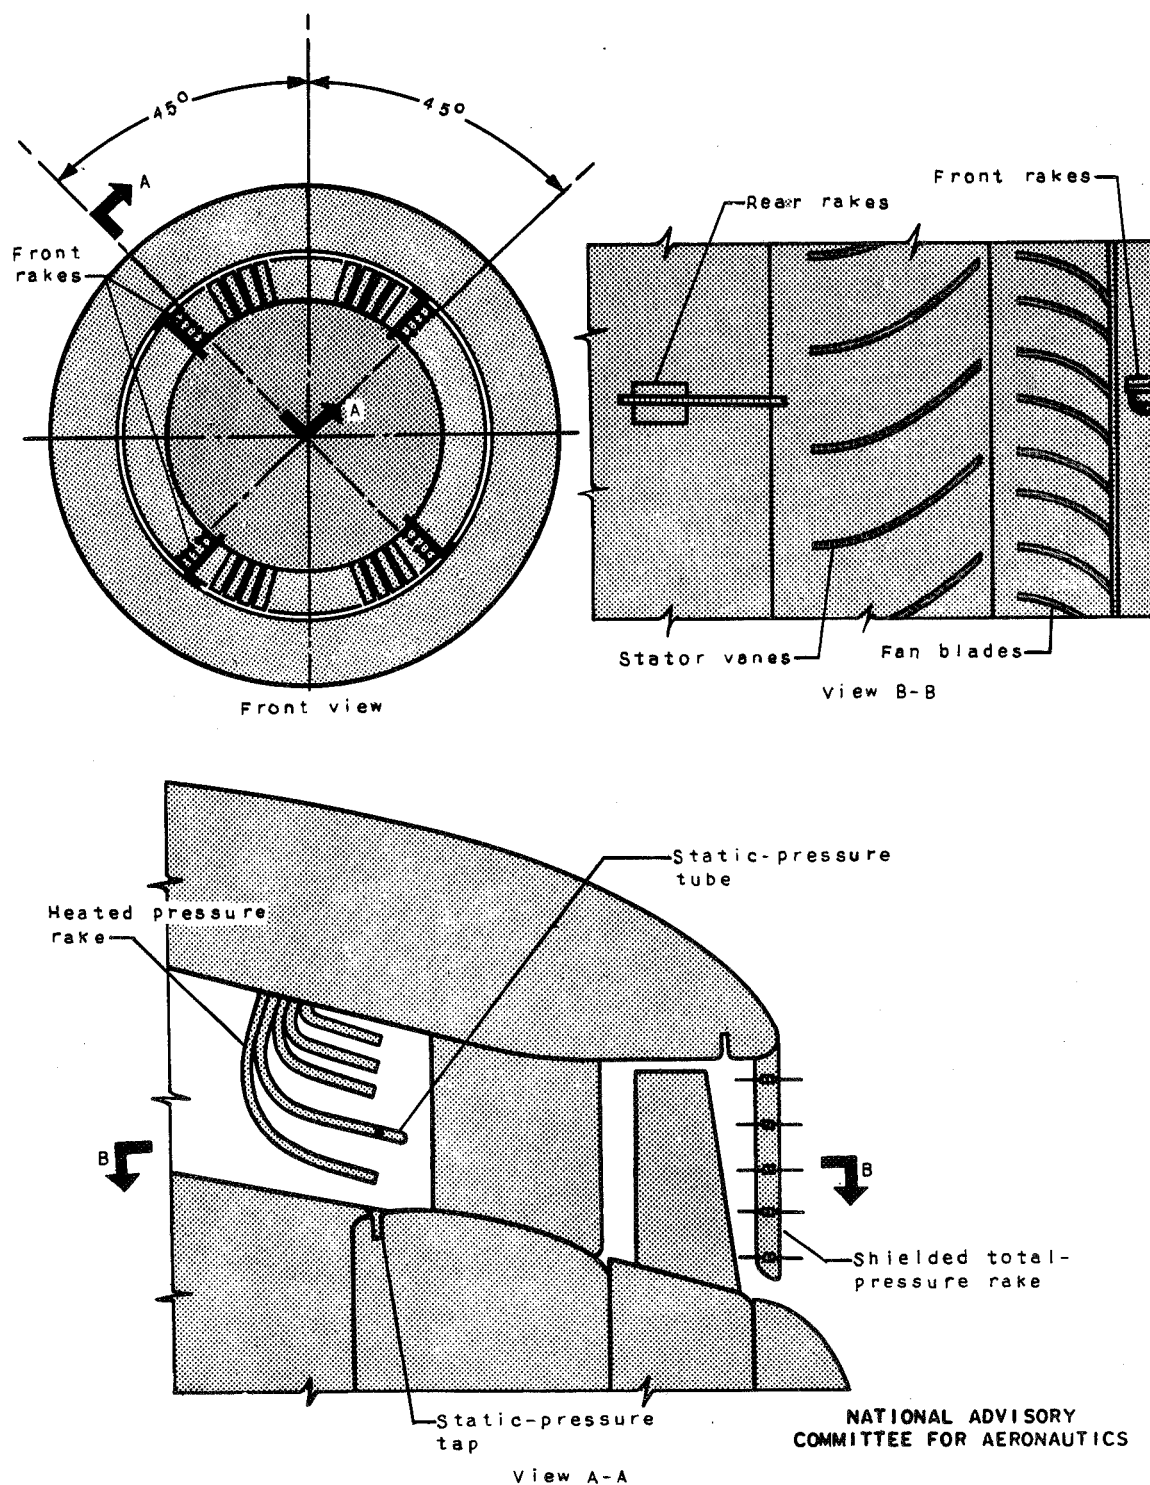
Figure 2. - Location of pressure-tube rakes in cooling-fan installation.

Instrumentation. - Total pressure in front of the fan and total and static pressure behind the stator vanes were measured by pressure-tube rakes (fig. 2). Four equally spaced rakes of shielded total-pressure tubes were located at the lip of the engine cowling between the fan and propeller. These rakes were unheated because of the extreme difficulty in heating small shielded total-pressure tubes and hence were used only on nonicing pressure-distribution studies. Electrically heated rakes consisting of four total-pressure tubes and one static-pressure tube were installed behind the stator vanes at four equally spaced positions corresponding to the positions of the front rakes. In addition, static pressures were measured on the inner wall of the diffuser in the plane of the rear rakes. All the pressures were indicated on a multiple-tube manometer and were photographically recorded.

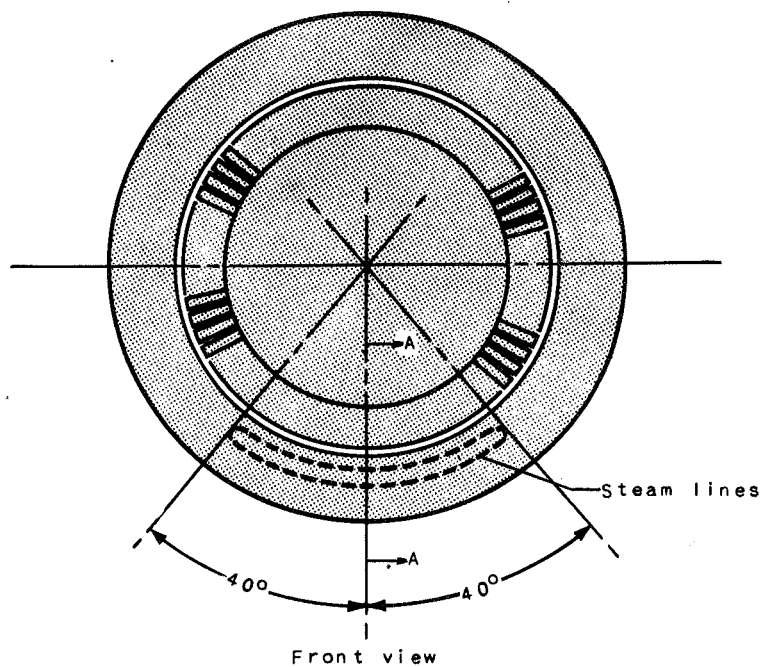
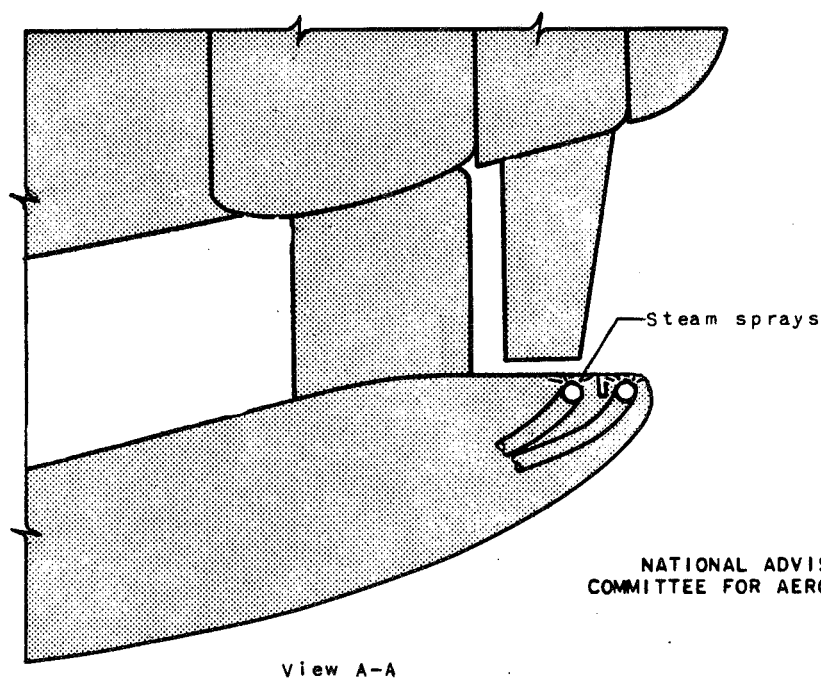
Figure 3. - Location of steam lines in cooling-fan installation.

Steam-heat installation. - In order to investigate the elimination of ice on the engine-cowling lip and the consequent scraping of the fan-blade tips, one steam line with jets 0.10-inch in diameter and spaced 1/2 inch apart was placed inside the cowling lip and another was located outside the inlet duct 2 inches behind the first line (fig. 3). These lines were of 3/8-inch copper tubing and extended approximately 40° on each side of the center line in the lower half of the cowling. Steam heating was confined to the lower quarter of the cowling because of time limitations and also to provide an unheated area for comparison.

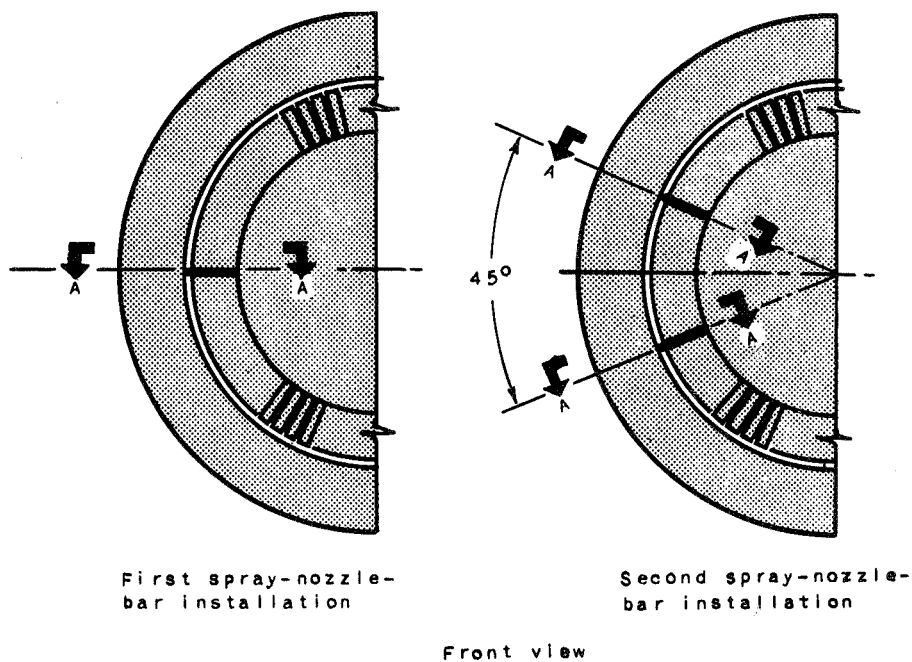
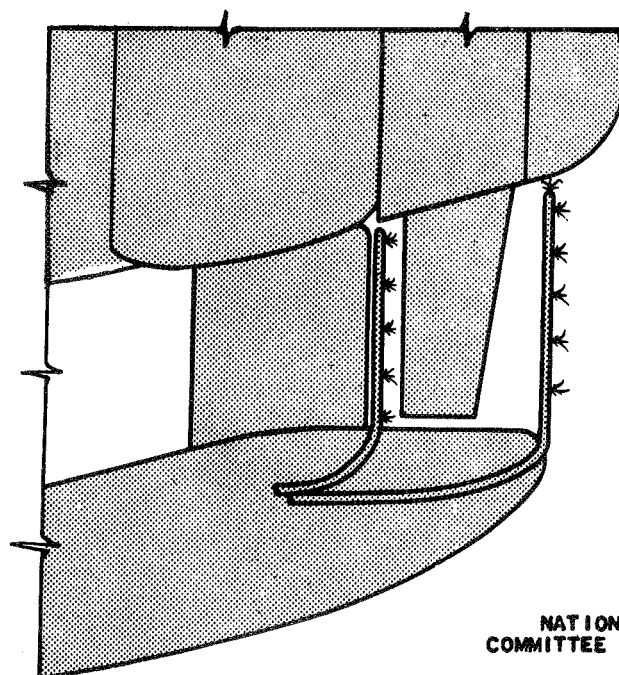
Figure 4. - Location of alcohol spray nozzle bars in cooling-fan installation.

Alcohol de-icing installation. - In the investigation of the use of isopropyl alcohol for de-icing, spray nozzle bars were mounted radially in front of the fan blades and also between the fan blades and the stator vanes (fig. 4). The spray nozzle bars, consisting of tubes having six small jets each 0.070 inch in diameter, were mounted to spray the alcohol forward in an attempt to obtain a good spray dispersion and at the same time to keep the spray tubes de-iced. For the first installation a single nozzle bar was mounted horizontally in front of the fan blades and one in a corresponding position was mounted at the leading edge of the stator vanes. For the second installation two spray nozzle bars located approximately 45° apart were similarly mounted in front of the fan blades and two spray nozzle bars were also mounted at the leading edge of the stator vanes. This second configuration was used to obtain a greater coverage of alcohol on the stator vanes and to accommodate greater flows. A variable-control alcohol pump provided flow rates up to 2.3 pounds per minute.

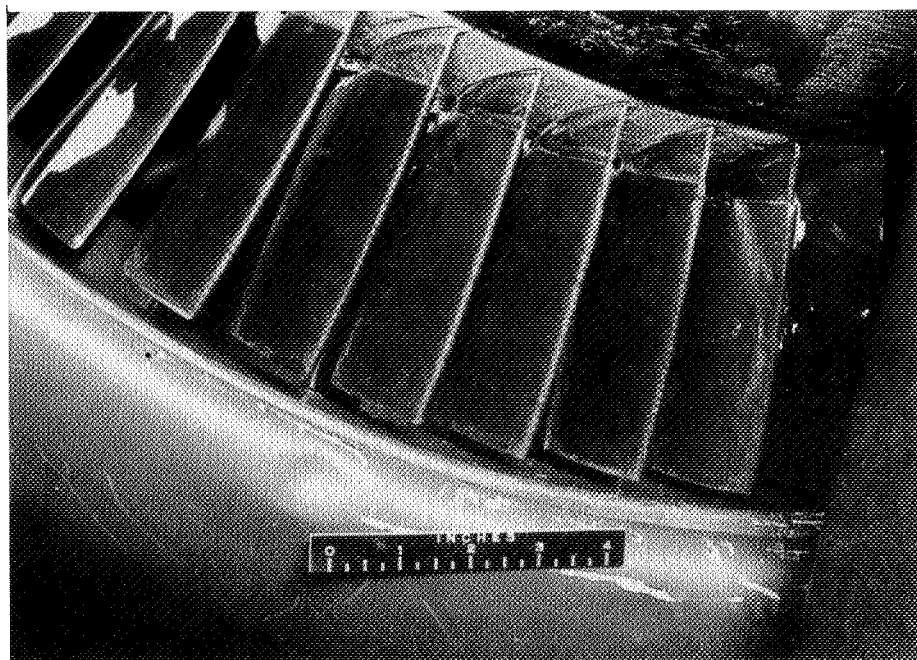
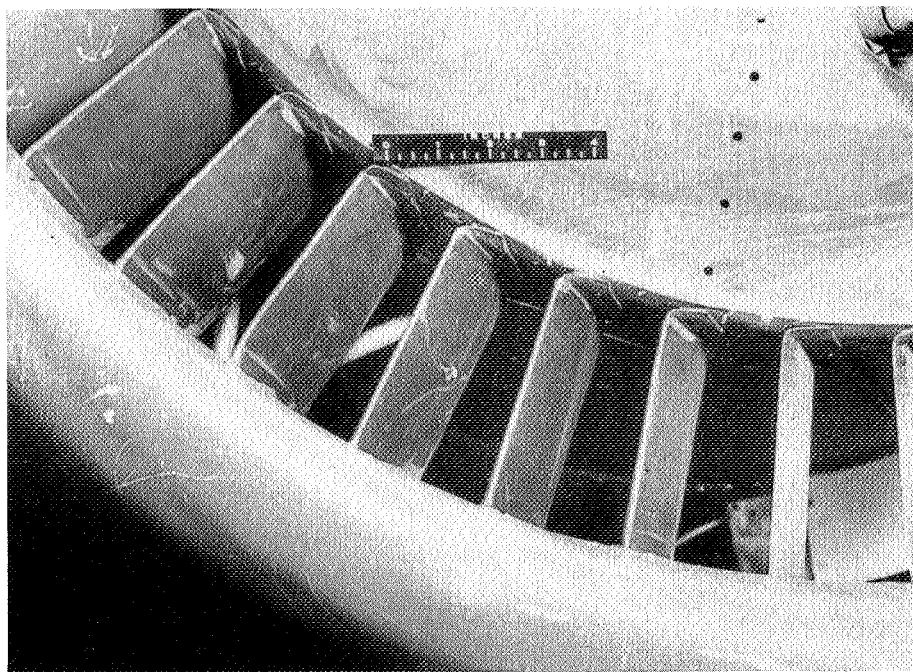
(a) Heaters on fan blades.

(b) Heaters on stator vanes.

Figure 5. - Electric blade heaters in cooling-fan installation.

Electrical-heat de-icing installation. - The use of electric heaters for de-icing was confined to the fan blades and stator vanes, as shown in figure 5. Because of the large number of blades and the anticipated large power requirements, only a few of the blades were so heated. The blade heaters were similar to propeller-blade de-icing heaters and consisted of parallel chordwise

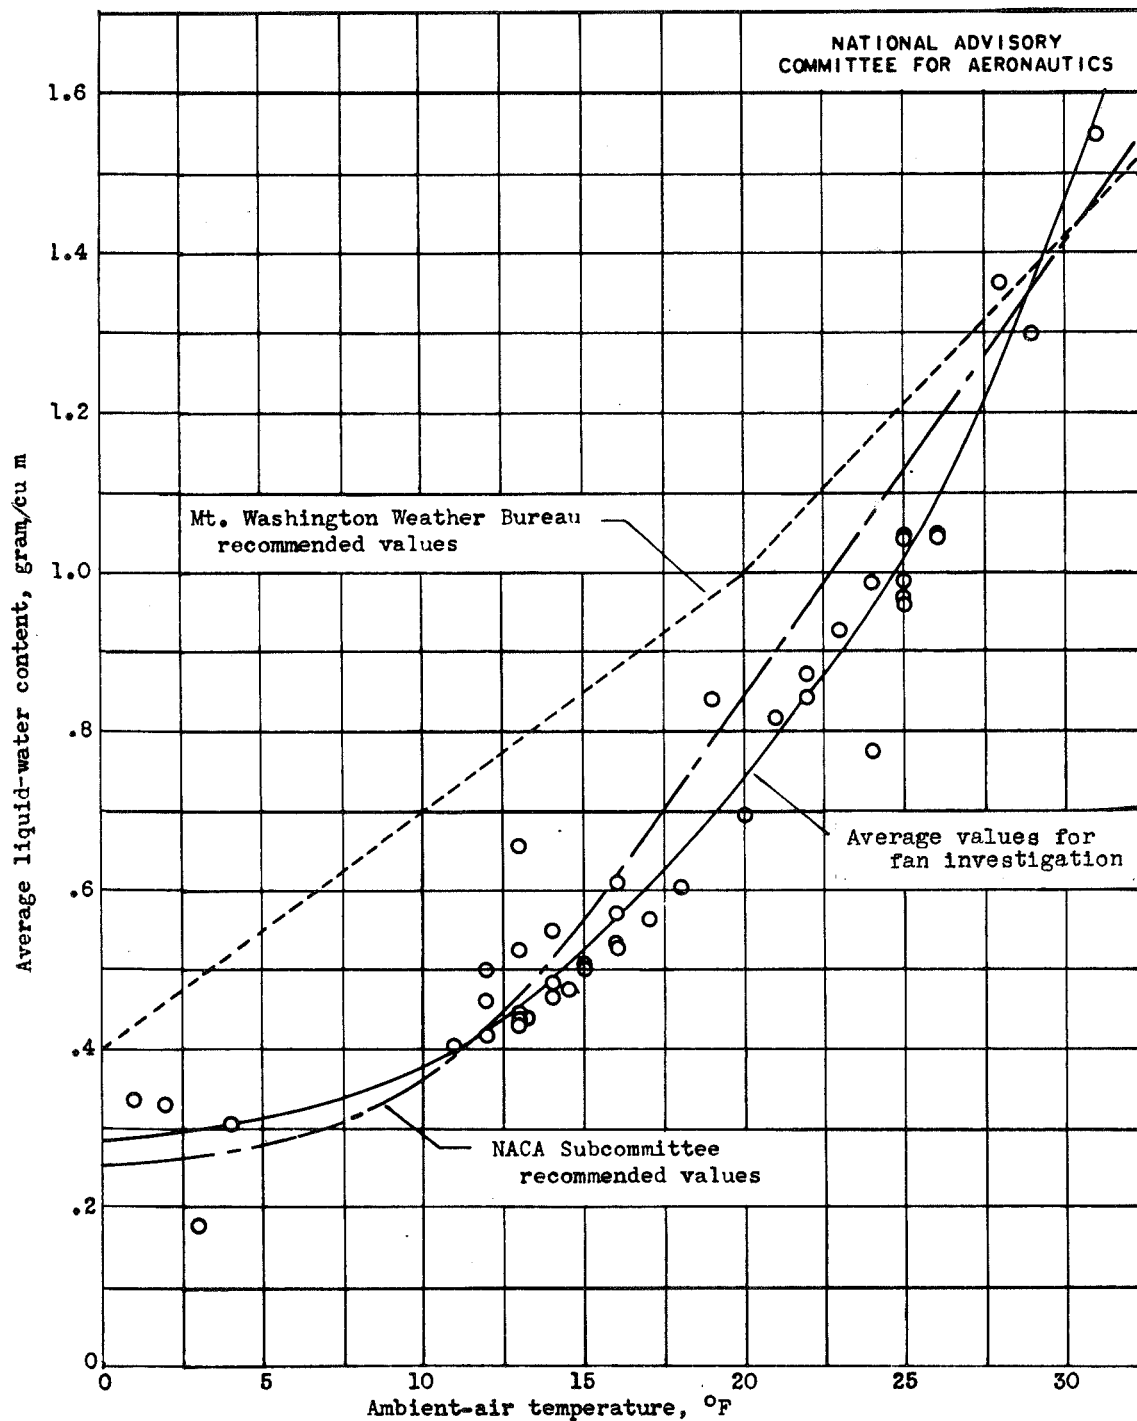
Figure 6. - Comparison of liquid-water content in icing research tunnel with recommended values.

Calibration of tunnel-icing conditions. - The icing conditions were defined by the ambient-air temperature and liquid-water content of the air. Figure 6 presents the variation of liquid-water content

with air temperature at the face of the cooling fan as determined by a survey conducted in the diffuser section of the icing research tunnel and a comparison of these conditions with the values recommended by the NACA Subcommittee on De-Icing Problems and by the Mt. Washington Weather Bureau meeting on June 19, 1945. The subcommittee values are one-half of the recommended maximum values and are for average or typical icing. Vertical cylinders rotating about their axes were installed in the diffuser section and, from measurements of the local velocity and the ice accumulation per unit time on these cylinders, the average liquid-water content in grams per cubic meter for each condition of tunnel air velocity, ambient-air temperature, and spray-water input pressure was computed by the method of Langmuir of the General Electric Company. Droplet size was also measured but no consistent correlation with air temperature was obtained. An average droplet size of 55 microns was obtained in the icing research tunnel for the range of air temperature of 0° to 32° F as compared with the recommended averages of 10 and 30 microns, respectively, at these temperatures. This variation in droplet size was not considered important, however, because the collection efficiency of small objects such as the thin fan blades and stator vanes is known to be very close to 100 percent. Although the liquid-water concentrations are slightly less than the recommended values for most of the temperature range, the experimental values are nevertheless representative of moderate-to-light icing conditions encountered in the United States. This survey was made approximately 3 months before the cooling-fan investigation. Although time limitations prevented any extensive checks of the liquid-water content and distribution, visual observations of the spray cloud and icing of the installation and tunnel, together with readings of spray-water input pressures, indicated that the icing conditions were fairly constant and in fairly close agreement with the indicated values for the cooling-fan investigation. A velocity survey made after this investigation indicated, however, that the icing of the contraction section of the tunnel resulted in an increase in the thickness of the tunnel boundary layer with a corresponding increase in the velocity at the center of the tunnel. In addition to the change in velocity distribution, this increase in boundary layer also caused some changes in liquid-water content and distribution.

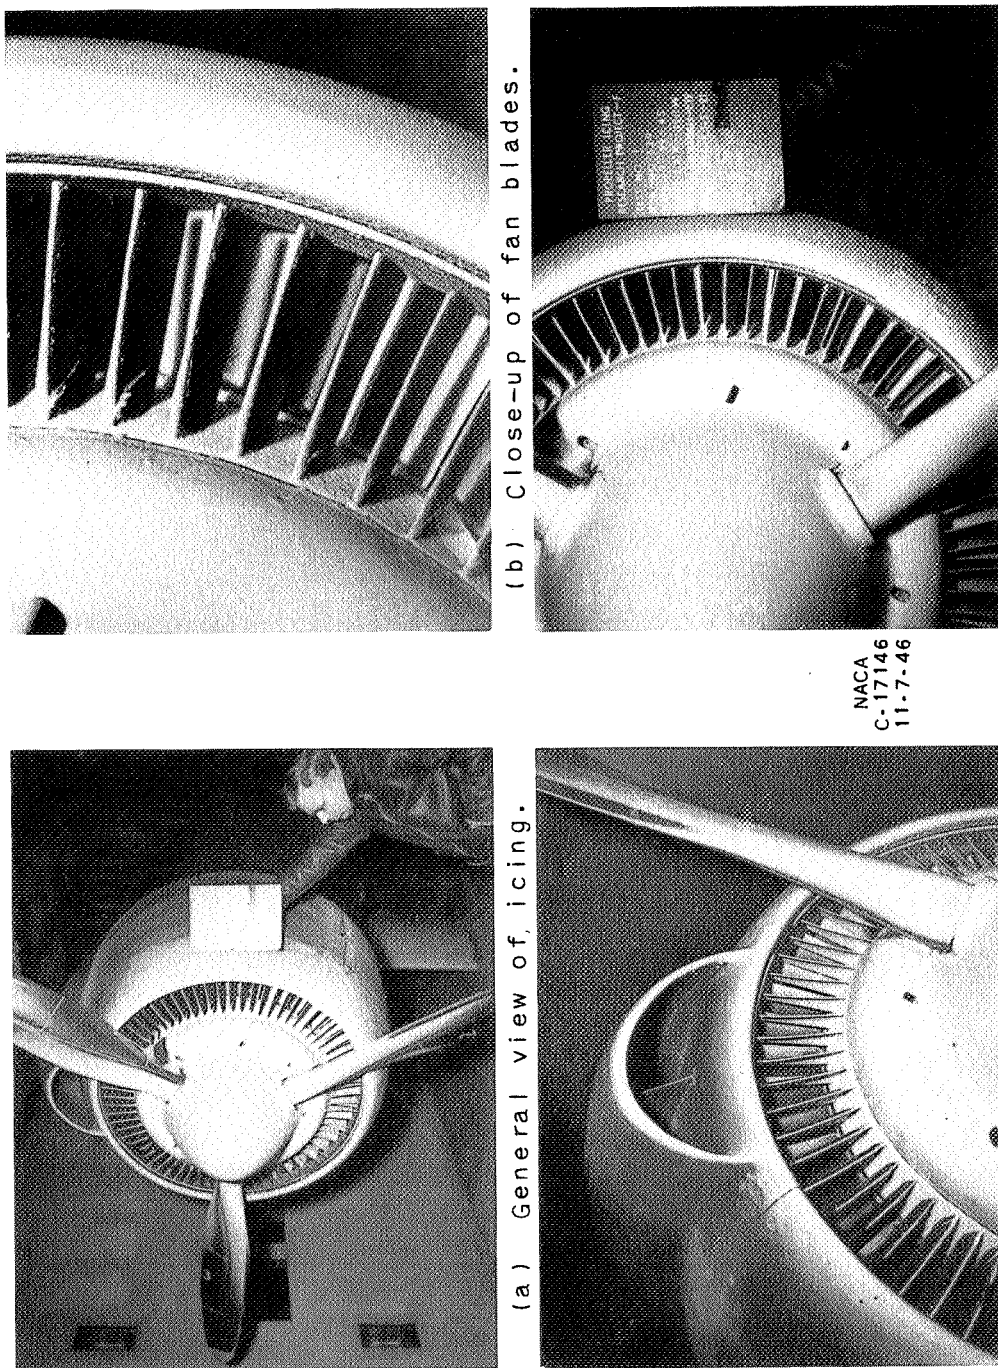
Figure 7. - Ice formations on cooling-fan installation after 5-minute run at air temperature of 20° F, liquid-water content of 0.3 gram per cubic meter, and fan speed of 872 rpm.

The only condition at which the air-flow coefficient ratio did not markedly decrease was at an air temperature of 2° F, liquid-water content of 0.3 gram per cubic meter, and fan speed of 872 rpm (fig. 13). Photographs of icing at these conditions (fig. 7) show only a negligible ice build-up on both the fan blades and stator vanes. At 16° F, 0.5 gram per cubic meter, and 897 rpm, the air-flow coefficient ratio decreased, approaching the minimum required value in 5 minutes; whereas at 14° F, 0.5 gram per cubic meter, and 1060 rpm the flow-coefficient ratio fell to the minimum required value in $3\frac{3}{4}$ minutes, continued to decrease, and reached a fairly stable value after 6 minutes. Photographs of typical icing at these two conditions (figs. 8 and 9) show relatively light icing of the stator vanes at both speeds with most of the ice on the leading edge and concave face of the fan blades and extremely large formations at the higher fan speed. At approximately the same fan speeds, as the experiments at 897 and 1060 rpm, and at 23° F, and 0.9 gram per cubic meter, the cooling-air-flow coefficient fell off sharply, reaching the minimum required value in 2 to 3 minutes, and continued to decline with a complete stoppage of the flow occurring in 5 to 6 minutes. Photographs of typical icing at these conditions (figs. 10 and 11) show relatively little ice on the fan blades with the stator vanes completely blocked by very heavy formations.

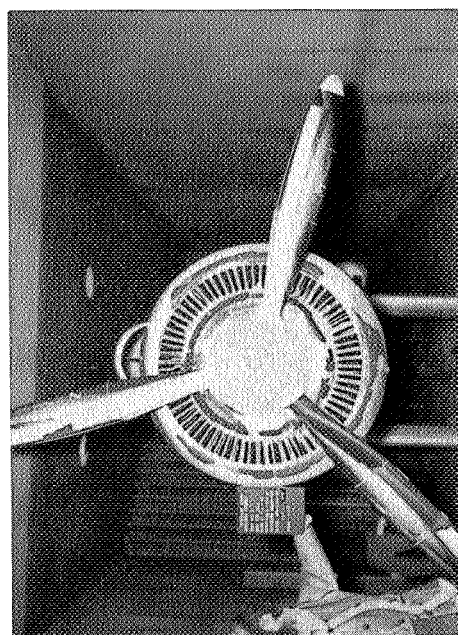
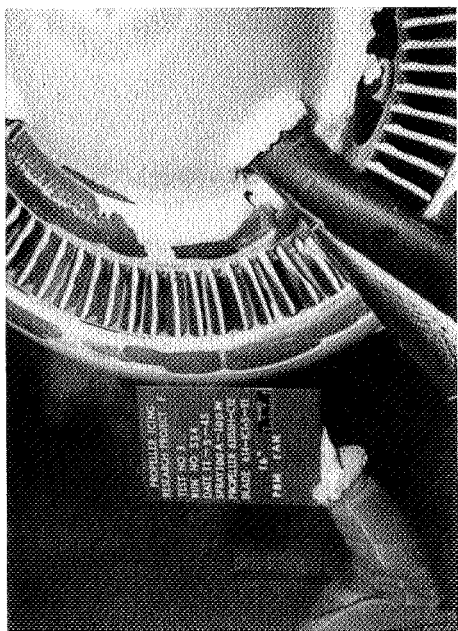
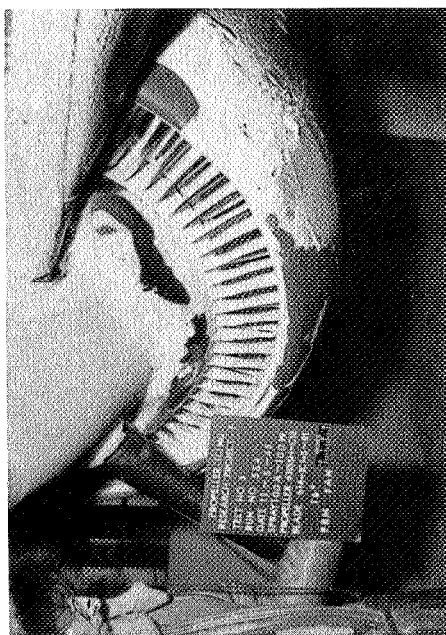
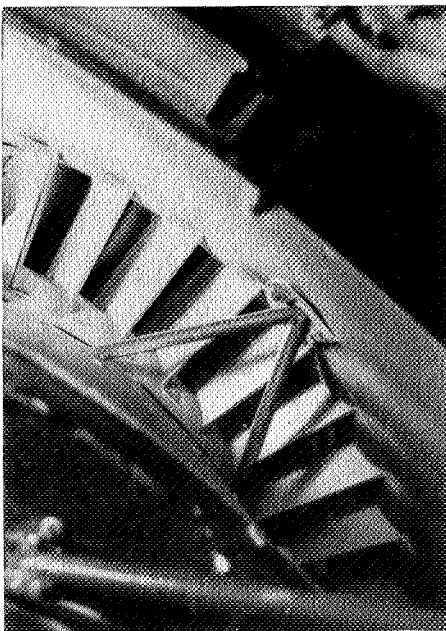
(a) General view of icing.

(b) View of ice formations on fan and spinner.

(c) Close-up of fan blades.

(d) View looking forward showing ice formations on stator vanes.

Figure 8. - Ice formations on cooling-fan installation after 5-minute run at air temperature of 46°F , liquid-water content of 0.5 gram per cubic meter, and fan speed of 897 rpm.

The variation in the pressure-coefficient ratio at the same speed and icing conditions (fig. 14) exhibited similar trends. At 14° and 16° F (figs. 8, 9, and 14), the decrease in pressure coefficient was primarily due to icing of the fan blades.

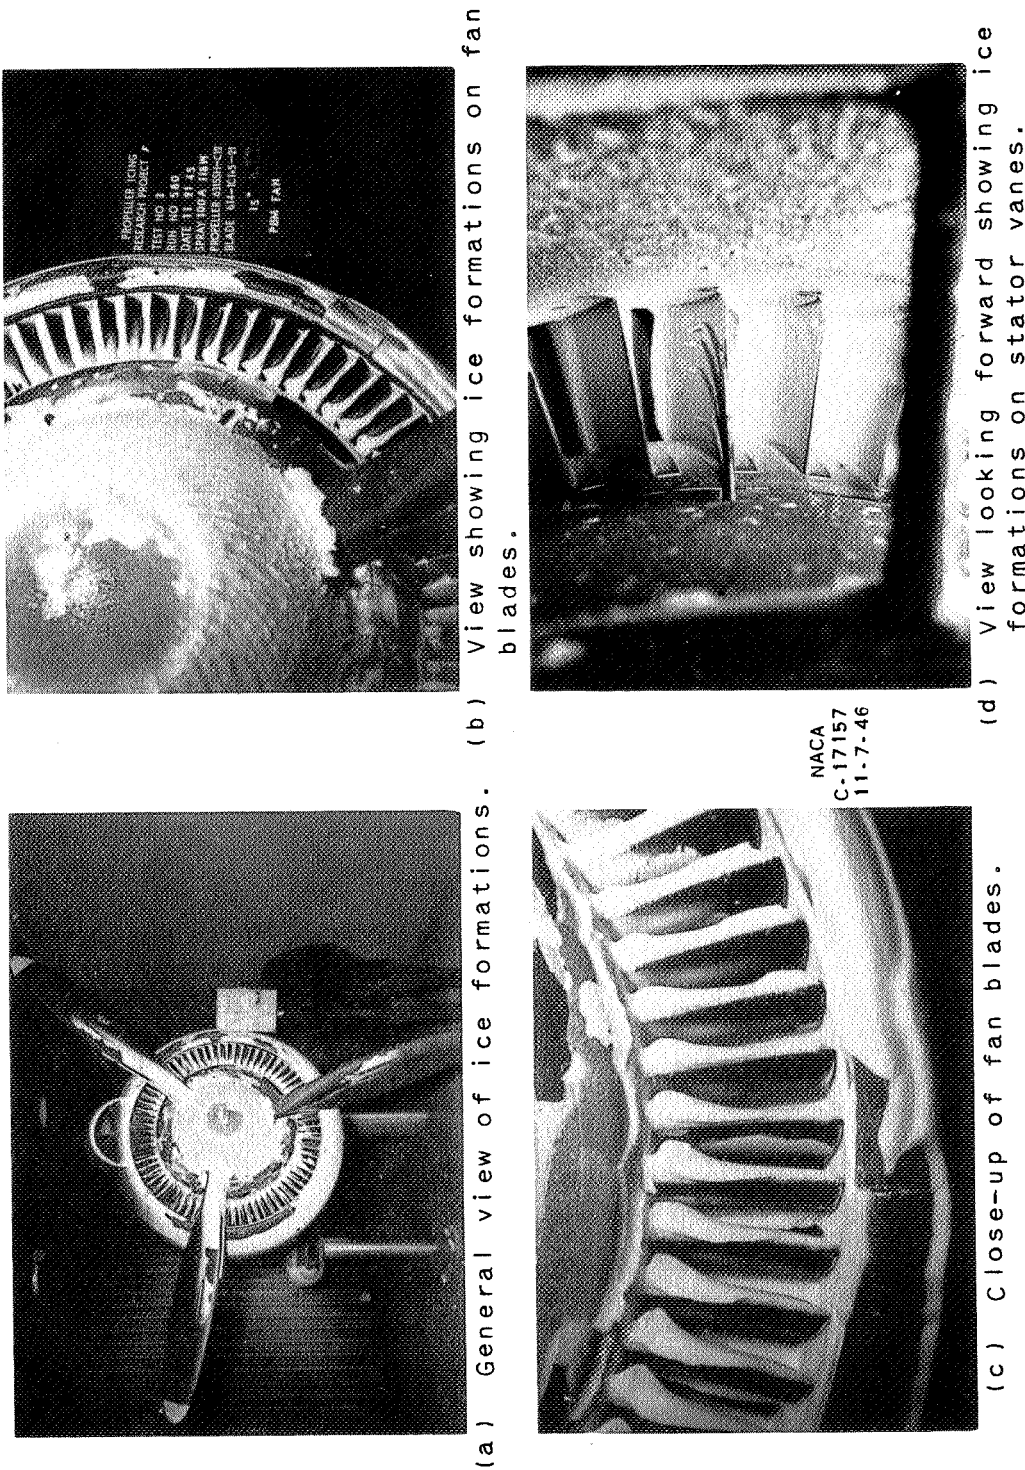
Figure 9. - Ice formations on cooling-fan installation after 10-minute run at air temperature of 14°F , liquid-water content of 0.5 gram per cubic meter, and fan speed of 1060 rpm.

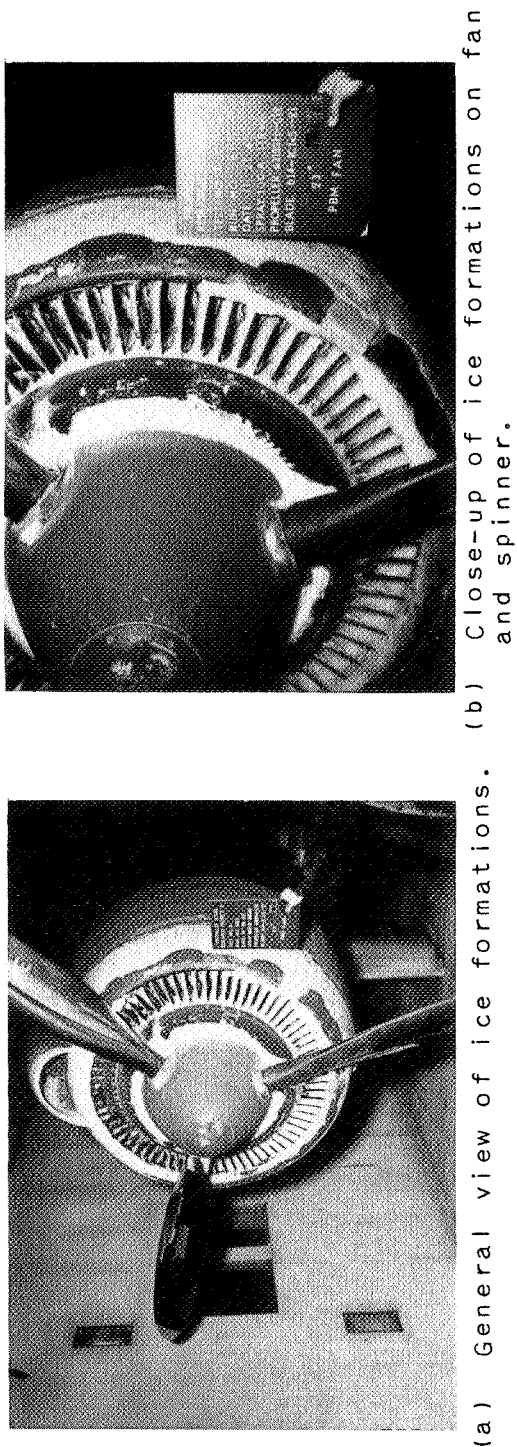
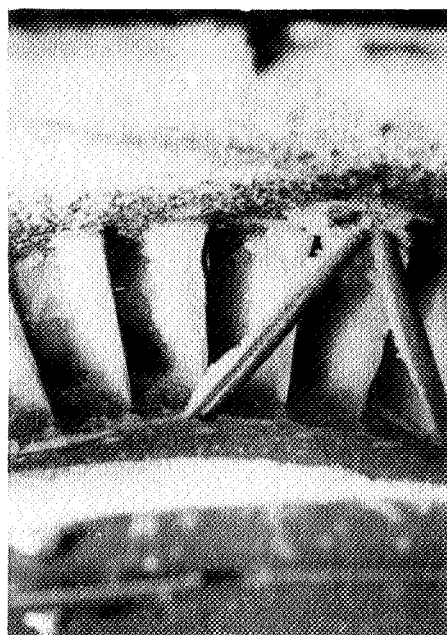
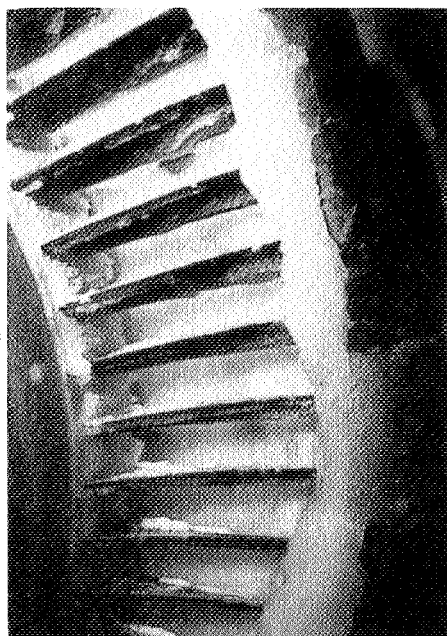
(c) Close-up showing ice formations on (d) View looking forward showing ice formations blocking stator vanes.

Figure 10. - Ice formations on cooling-fan installation after 5-minute run at air temperature of 23° F, liquid-water content of 0.9 gram per cubic meter, and fan speed of 872 rpm.

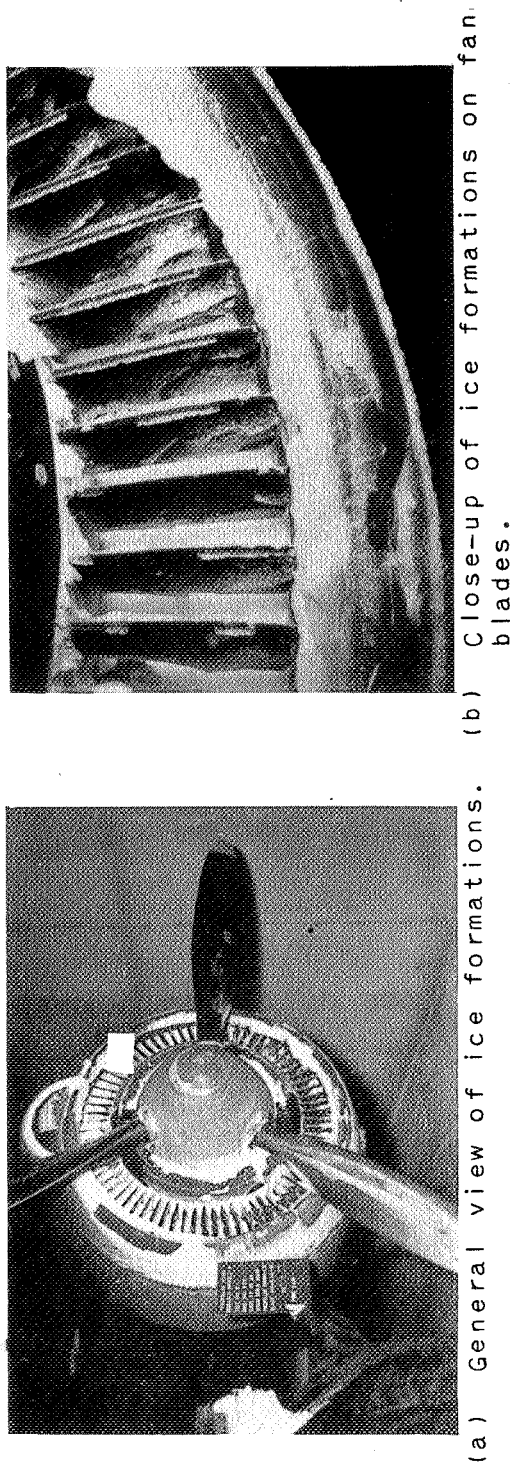
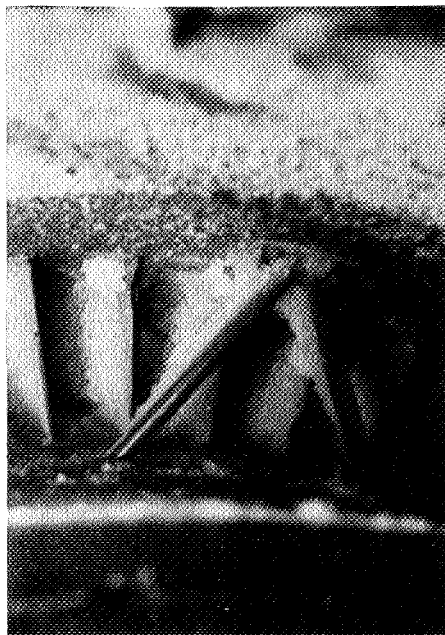
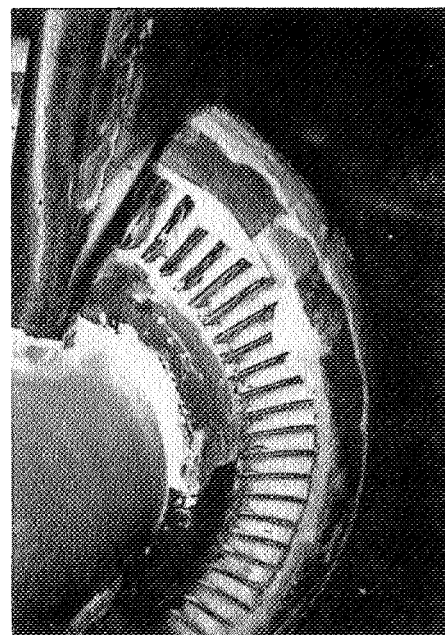
Figure 11. - Ice formations on cooling-fan installation after 7-minute run at air temperature of 23° F, liquid-water content of 0.9 gram per cubic meter, and fan speed of 1065 rpm.

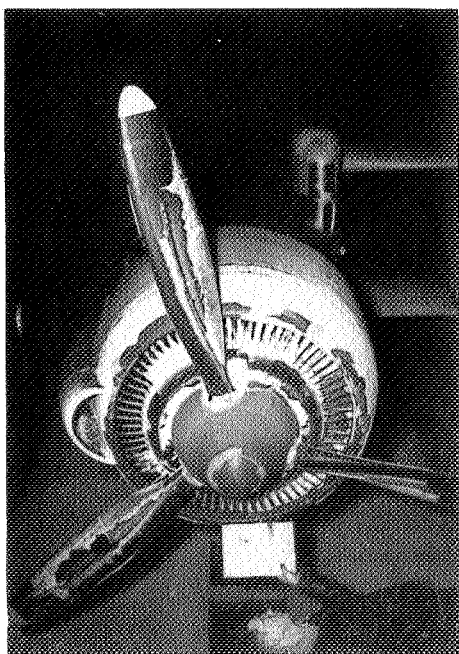
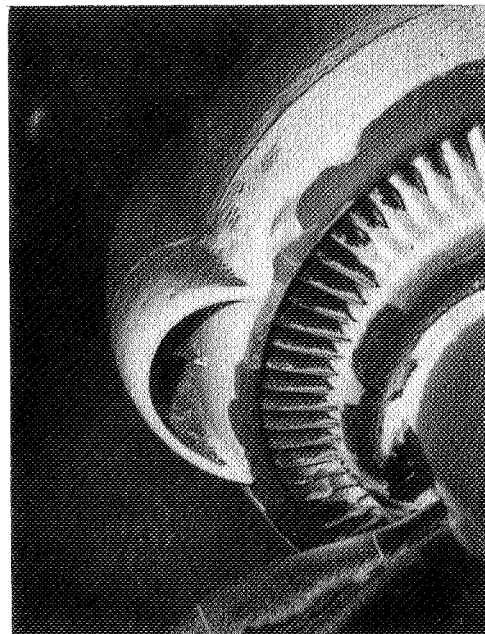
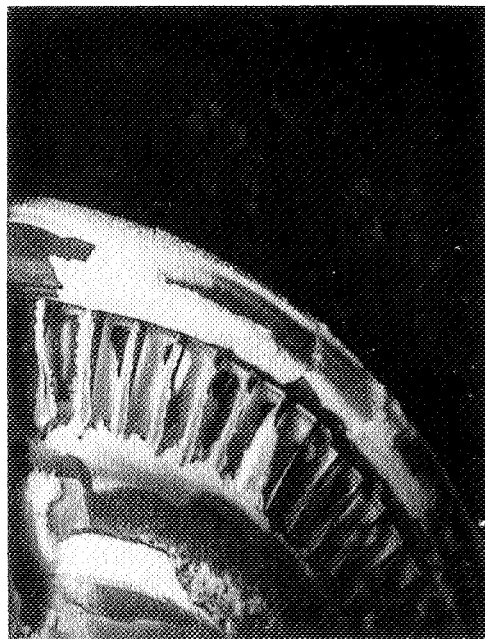
(a) General view of ice formations.

(b) Close-up showing bridging of ice over fan blades.

(c) Close-up showing blades that had thrown off ice.

Figure 12. - Ice formations on cooling-fan installation after 5-minute run at air temperature of 17° F, liquid-water content of 0.7 gram per cubic meter, and fan speed of 872 rpm.

Although no performance data were obtained at 17° F and 0.7 gram per cubic meter, visual observations revealed serious icing at this condition. As shown by the photographs in figure 12, heavy icing of the fan blades was obtained with medium formations

on the thrust face and leading edge of the stator vanes. At one time during this run, stroboscopic observations showed the fan blades to be fully bridged over but much of this ice was later thrown off.

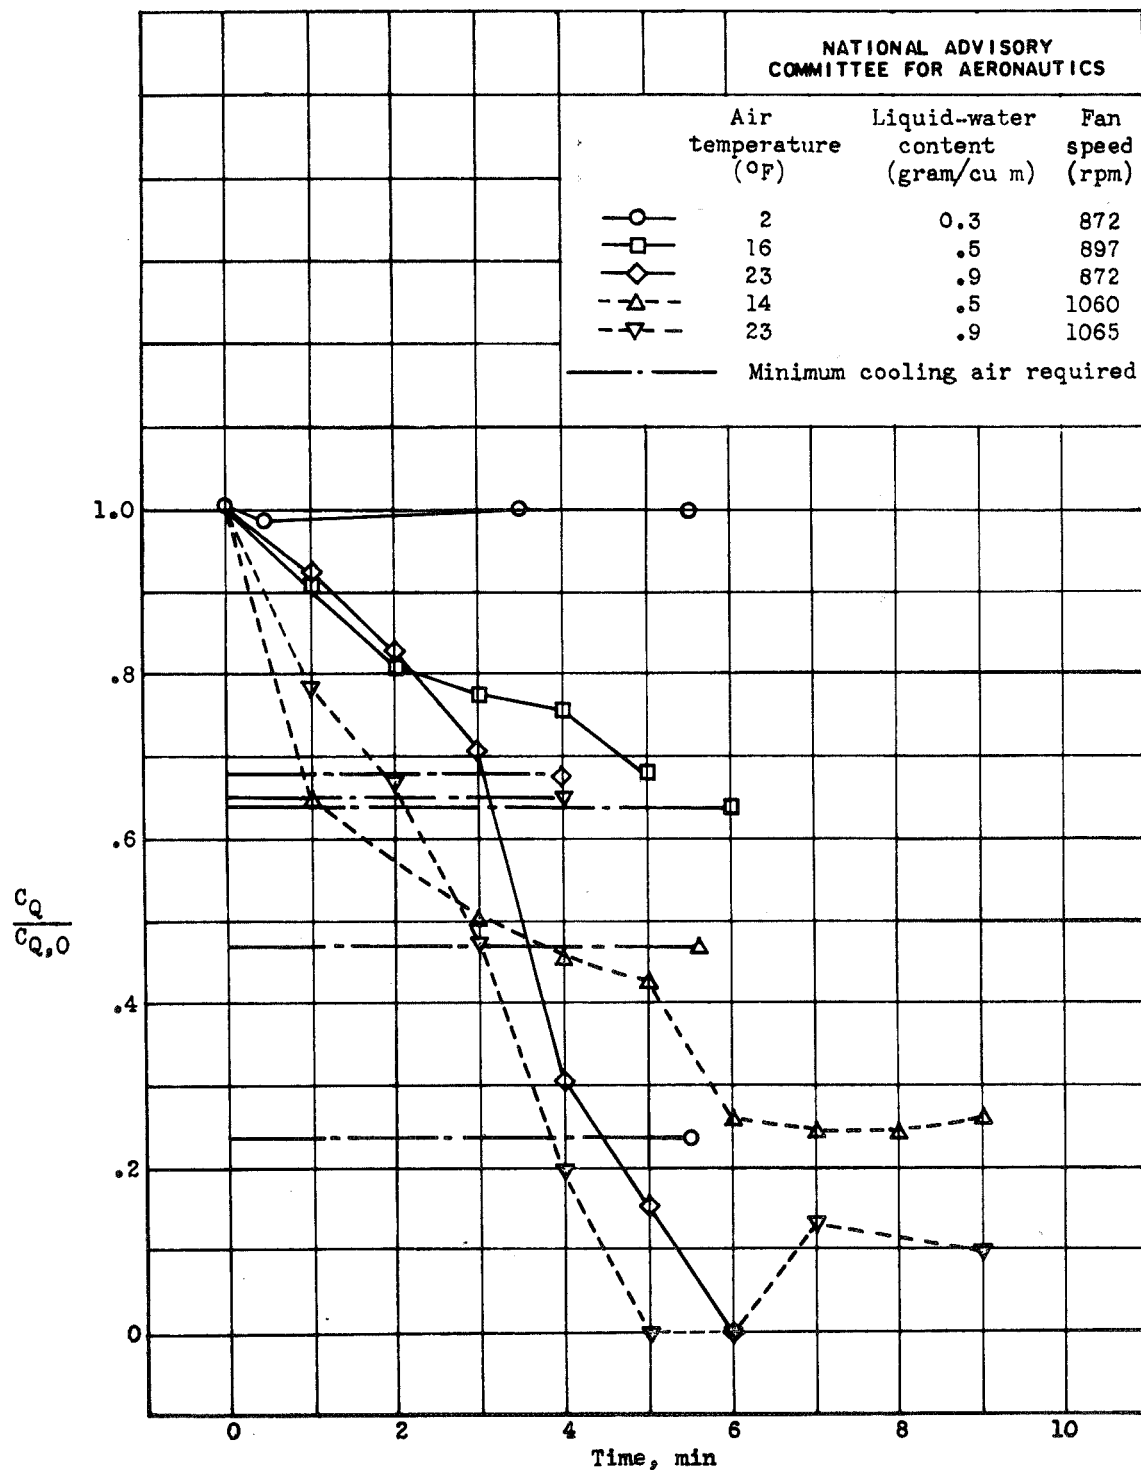
Figure 13. - Reduction in cooling-air-flow coefficient ratio for various icing and fan-speed conditions for investigation of cooling-fan installation.

of the fan before icing $\frac{C_Q}{C_{Q,0}}$ and $\frac{C_P}{C_{P,0}}$, respectively, are plotted against icing time. Although insufficient data were available to compare the effects of icing at all icing and performance conditions, the results shown in figures 13 and 14 are complete enough to define the effects of icing on fan performance throughout the normal range of icing and performance conditions. The minimum air flow required for adequate engine cooling is indicated in figure 13 as computed from data supplied by the engine manufacturer.

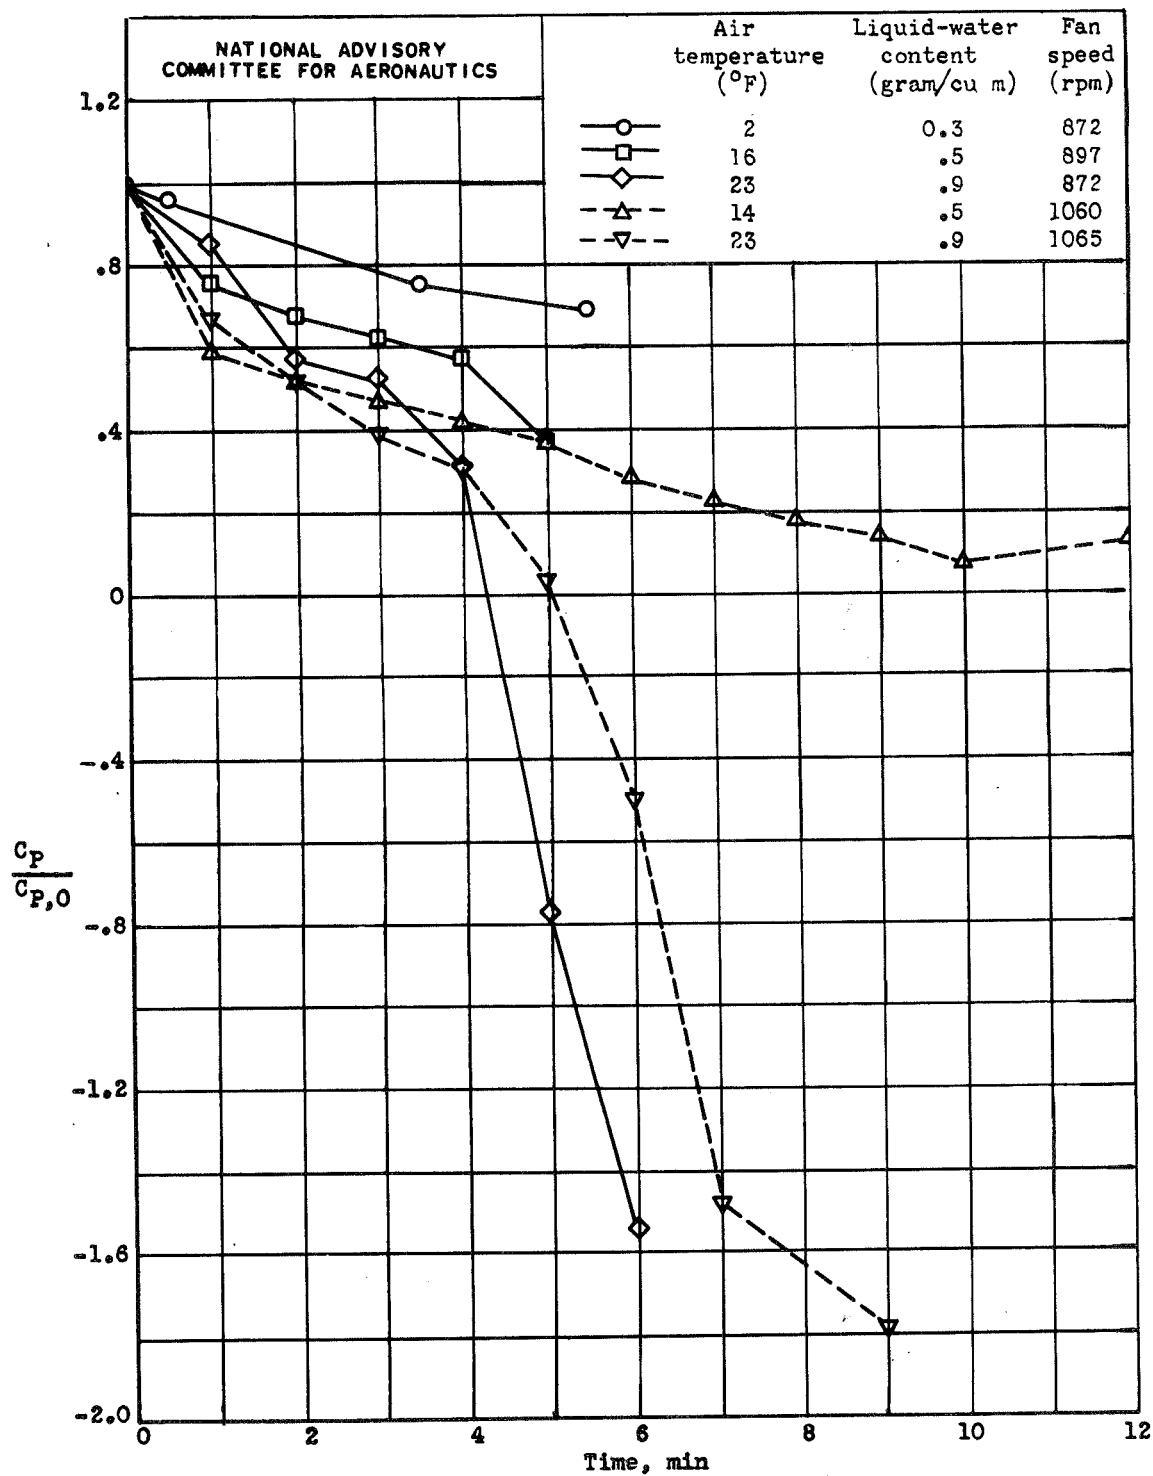
Figure 14. - Reduction in fan-pressure coefficient ratio for various icing and fan-speed conditions for investigation of cooling-fan installation.
